GIS-Based Risk Assessment and Mitigation of Road Slope Instability in Morotai Island Regency

Nindya Febri Iftika¹, Abdul Gaus², Ichsan Rauf^{3*}, Muhammad Taufiq Y.S⁴

¹Department of Civil Engineering, University of Khairun, Ternate 97719, Indonesia

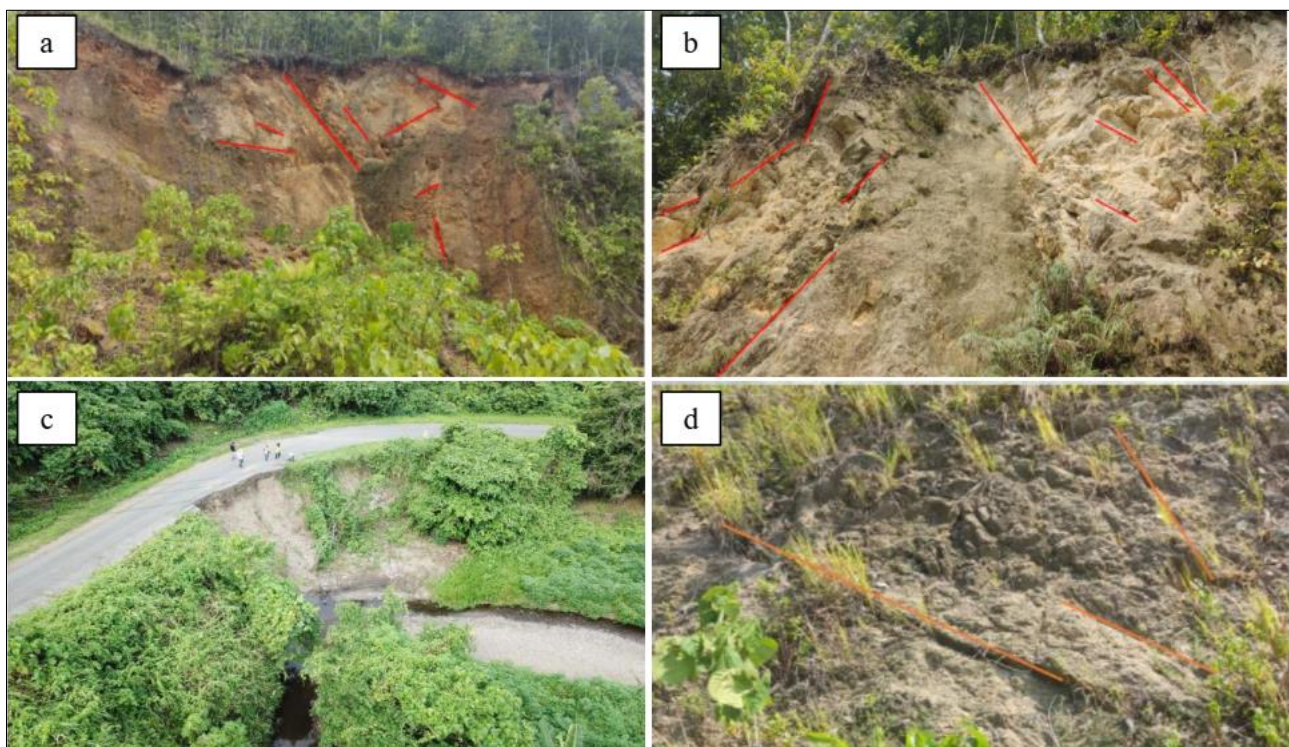
The field observation results indicate that slope failures at the study location are generally rock failures. This condition is found at the points along the Daeo/Sangowo – Bere bere road section, the Bere bere – Sopi road section, and the Sopi – Wayabula 1 road section. On the Sopi – Wayabula 3 road section, the type of failure observed is embankment failure. The illustration of the types of failures on several points observed has shown in Figure 2. Survey and inventory of potential slope failures at each point based on variables from each assessment indicator are recorded and described clearly and accompanied by field documentation. These results are then tabulated for each road slope number, as shown in Table 3.

Figure 2: Types of landslide in research site (a) rock collapse at section 61-021-001-A (b) rock collapse at section 61-021-001-B (c) fill collapse at section 61-0233-001-B (d) fill collapse at section 61-0233-002-B.

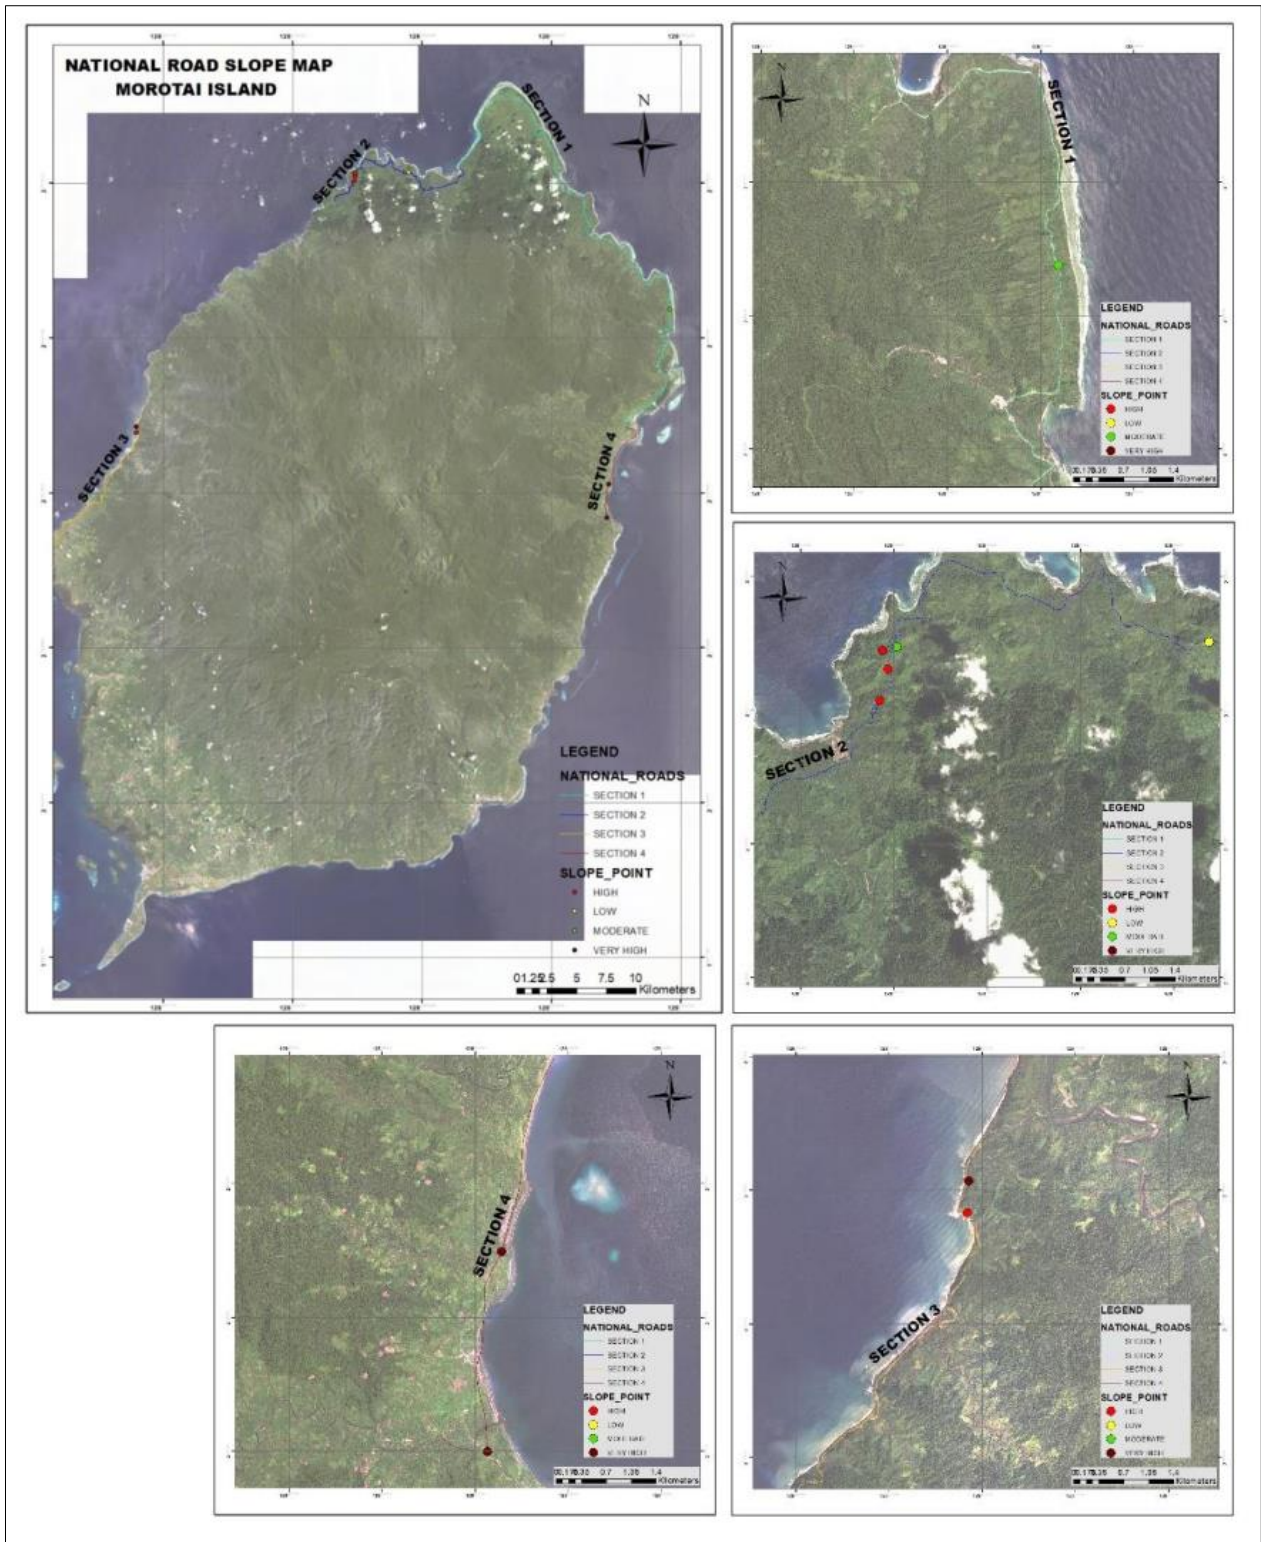
Referring to the summary of risk levels on the national road sections in Pulau Morotai Regency as shown in Table 6, four risk categories are identified. First, high-risk road sections are found at 3 points, and the mitigation for slope risk is road reconstruction. Second, high-risk road sections are identified at 4 points, and the mitigation for slope risk involves the installation of instruments and rehabilitation. Third, moderate-risk road sections are present at 2 points, and the mitigation for slope risk is road rehabilitation. Fourth, low-risk road sections are found at 1 point, and the mitigation for slope risk is routine and periodic maintenance.

Figure 3: The landslide risk map of road slopes in each section road on Maitara Island
