Case Report

Success Tips for Renewing Fractured Ceramic Veneer On Central Incisor

Abstract: This clinical report describes how to achieve a successful rebonding of a debonded porcelain veneer successfully using several procedures such as grinding enamel to eliminate the remaining adhesive from the first bonding and ultrasonic treatment of the veneer's surface. Care is given the bonding protocol in order to optimize the durability of the interface.

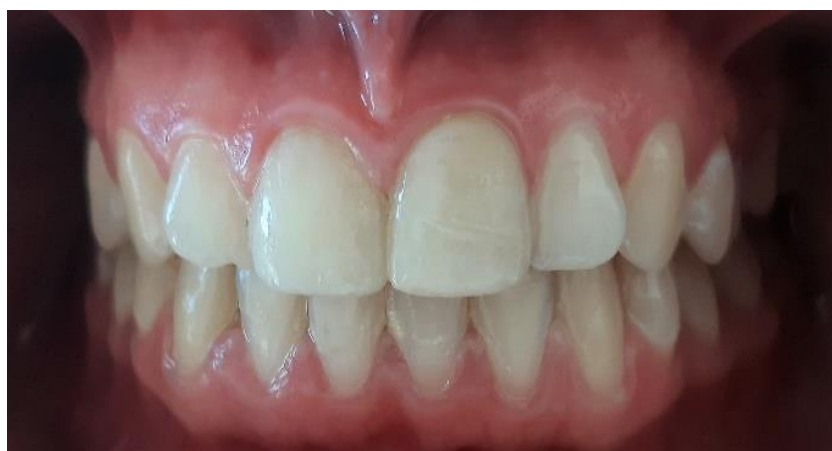
A healthy 23-year-old woman presented to our department with fractured veneer on the left central incisor 21. Clinical examination revealed a static fracture, the remainder of the veneer still remains intact on the tooth. According to the patient fracture occurred while she was eating a sandwich and since then teeth has become sensitive.

Fig-1: intraoral front view (fractured fragment temporary cemented)

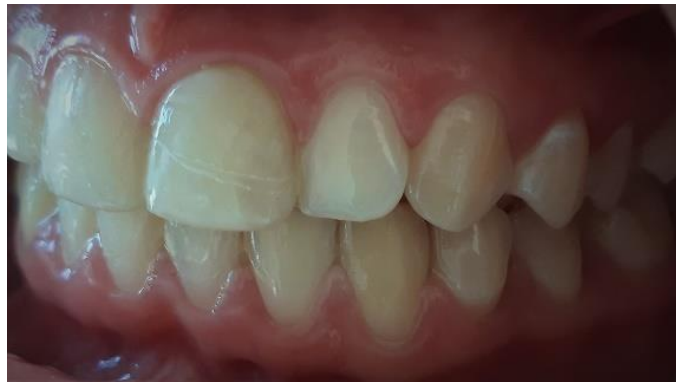
During the first appointment, intraoral photographs were taken (figure 1, 2) and first impression was taken for study models.

Fig-2: intraoral lateral view

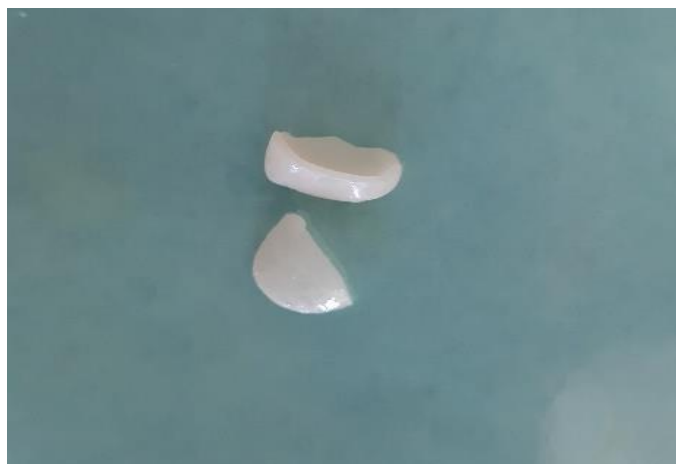
Then, debonding was performed using ultrasonic devices, the 2 fragments of fractured veneers were retrieved (figure 3). After that, the enamel was grinded to eliminate the underlying layer of previously treated enamel (mechanically) using diamond burs (figure4) and chemically using pumice polishing powder (figure5).

Fig-3: Fractured veneer

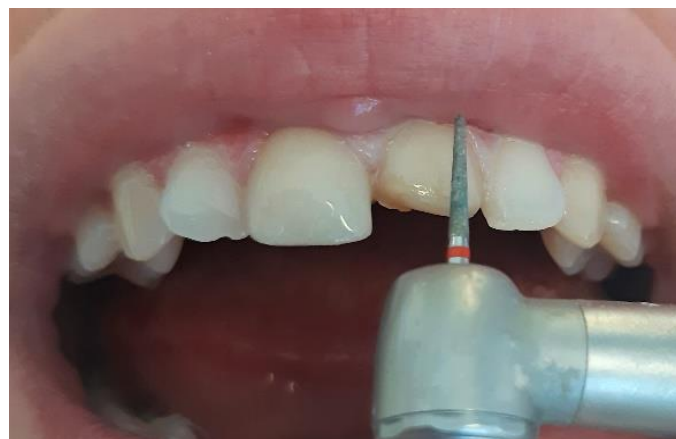
Fig-4: Grinding enamel using diamant burse

When rebonding porcelain veneer, the properties of the underlying layer of previously treated enamel can affect the rebonding strength. Probably, the surface of the enamel can contain adhesive remains even after removing all visible adhesive. The remaining adhesive can decrease the roughness of the enamel surface and therefore reduce also the rebonding strength. It has been reported that reetching does not remove this residual adhesive, so another method should be employed. Literature has shown that grinding enamel refreshes the surface for rebonding and improves bonding's properties [13].

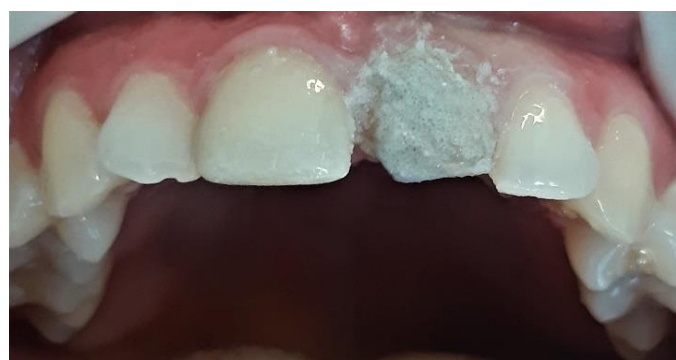
Fig-5: Grinding enamel using pumice powder

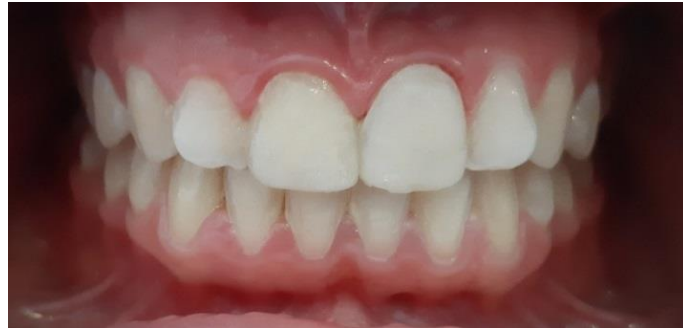
Fig-6: Temporary restoration

Consequently, final impression was made using light-body and heavy-body consistency polyvinylsiloxane (Virtual 380, Ivoclar Vivadent, Amherst, NY, USA) as well as temporary restoration using self-cured temporary composite material (Structur Premium, VOCO GmbH, Cuxhaven, Germany) (figure6).

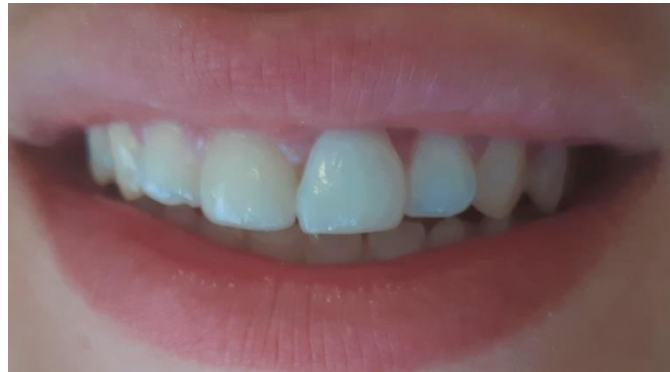
Fig-7: Fitting session

The following appointment, before bonding, the restorations were evaluated in terms of adaptation (figure 7).

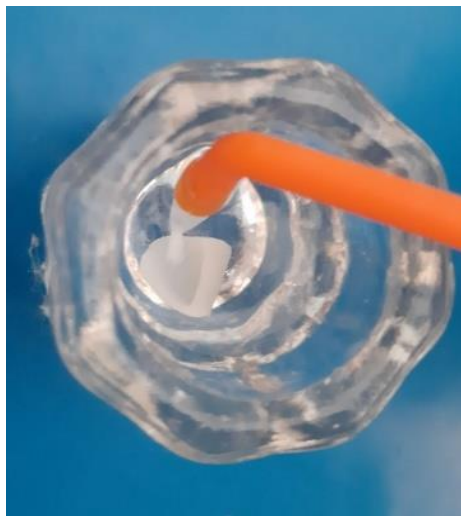
Fig-8: Immersing the restoration into alcohol

Firstly, the try-in was removed, washing it under running water, and, subsequently, 10% hydrofluoric acid was applied (Ceramic Etching Gel, Ivoclar) for 60 seconds. The sample was then rinsed thoroughly, then the restoration was immersed into 95% alcohol for 4 minutes (figure8). Consequently, silane (Monobond-Ivoclar) was applied for 60 seconds (figure 9a and 9b).

After acid etching the surface is rinsed and dried. However SEM studies (scanning electron microscopy) showed that, even after the etched surface is rinsed with copious amounts of water, a great number of acid crystals will stay deposited on the etched surface that may affect the bond strength. In order to eliminate this, the veneers should be placed into the ultrasonic cleaner. All residual acid and dissolved debris can be removed from the etched surface with an ultrasonic cleaning in 95% alcohol for 4 minutes, or acetone or distilled water.

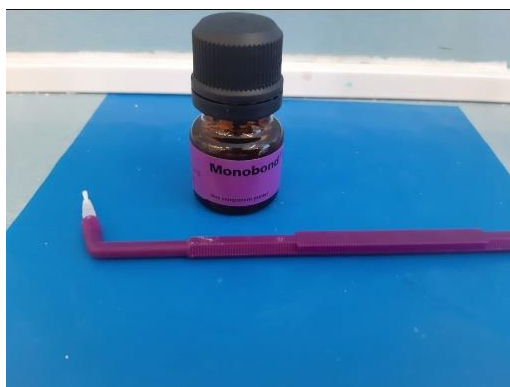
Fig-9a: silane application

Fig-9b: Silane

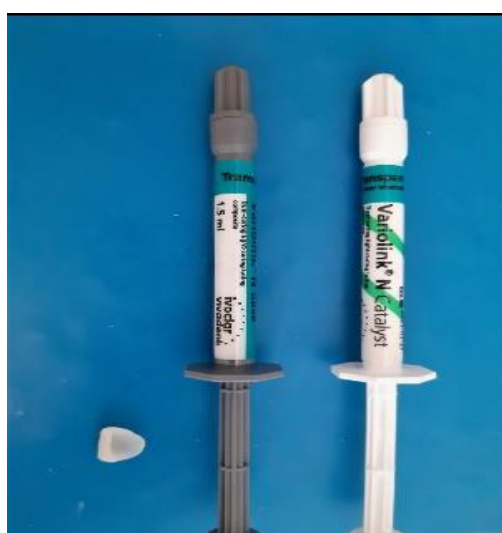
Fig-9e: The cement

The color of the adhesive cement was selected using a try in cement (Variolink II, Ivoclar Vivadent). Cementation of the restoration was performed using the appropriate cement color (color A1).

The adhesive system (Syntac-ivoclar) was applied for 30 seconds (figure 9 d). The light color cement (Variolink Esthetic LC, Ivoclar Vivadent) was applied to the restoration which was placed onto the tooth (figure 9 e). Excess cement was removed with a micro brush and using a floss in the interproximal surfaces before light curing for 20 seconds on the facial surface. Finally, a glycerin layer (Liquid Strip, Ivoclar Vivadent) was applied between the union piece and tooth, and resin cement was light cured for another 20 seconds, aiming at blocking the oxygen entrance.(figure 10a and figure 10b).

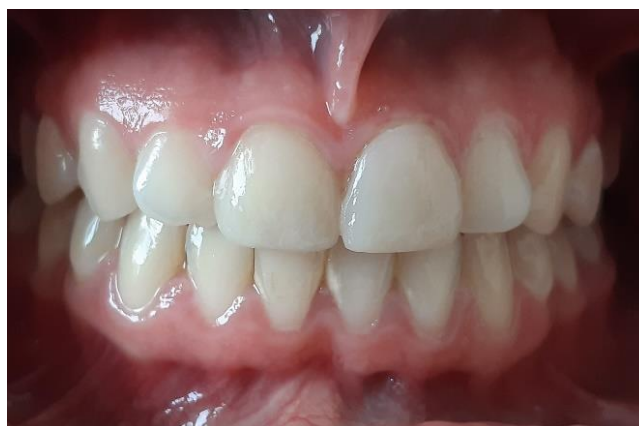
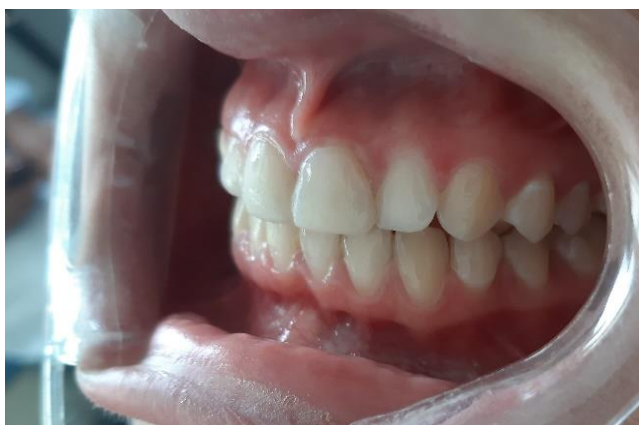
Fig-10a: front view

Fig-10b: lateral view
Fig-10: Final result
